# **Dubbo Zirconia Project**

## **Soils and Land Capability Assessment**

**Sustainable Soils Management Pty Ltd**

**August 2013**

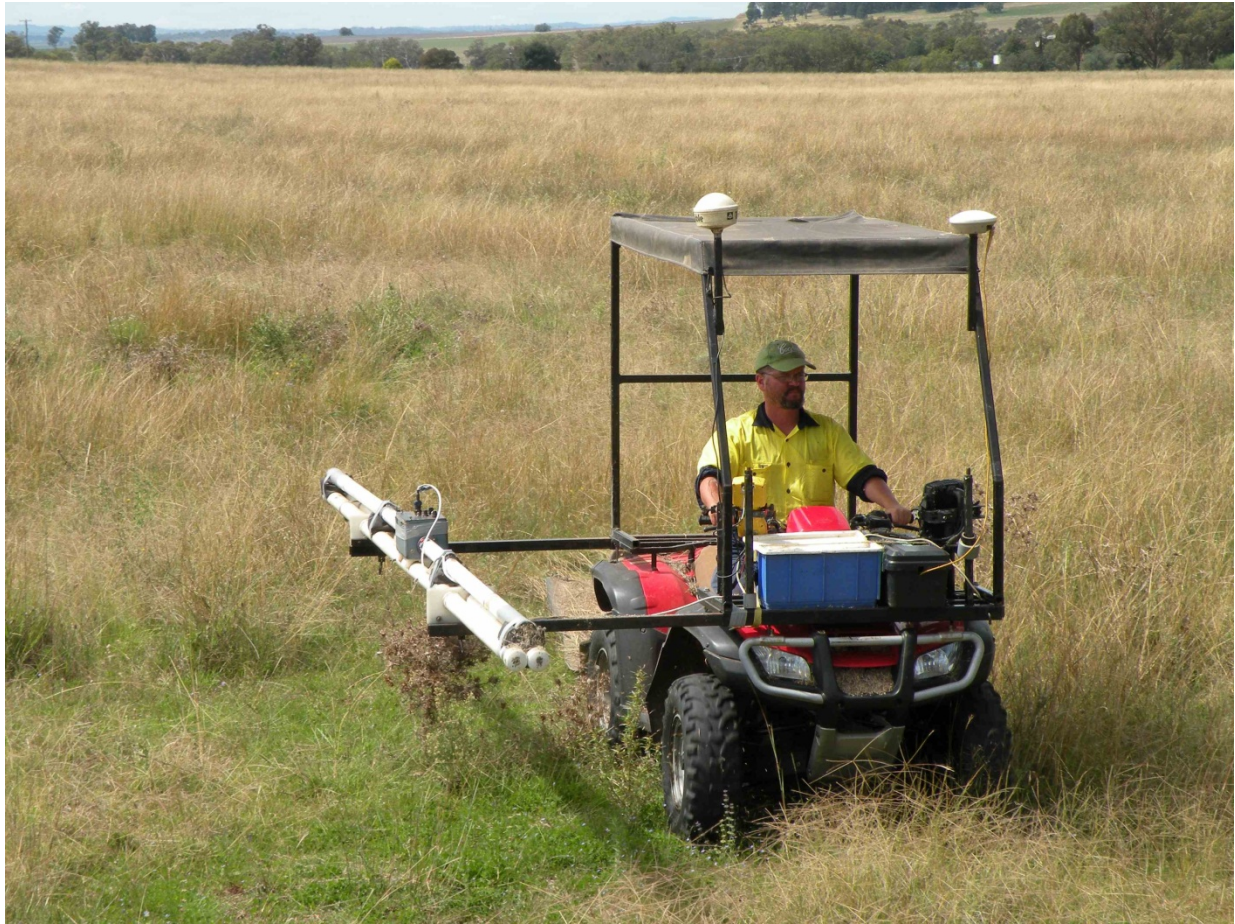
**Plate 1 EM Survey Equipment. EM 31 is on frame beside operator, EM 38 is on conveyor belt dragged behind 4 wheel bike.**

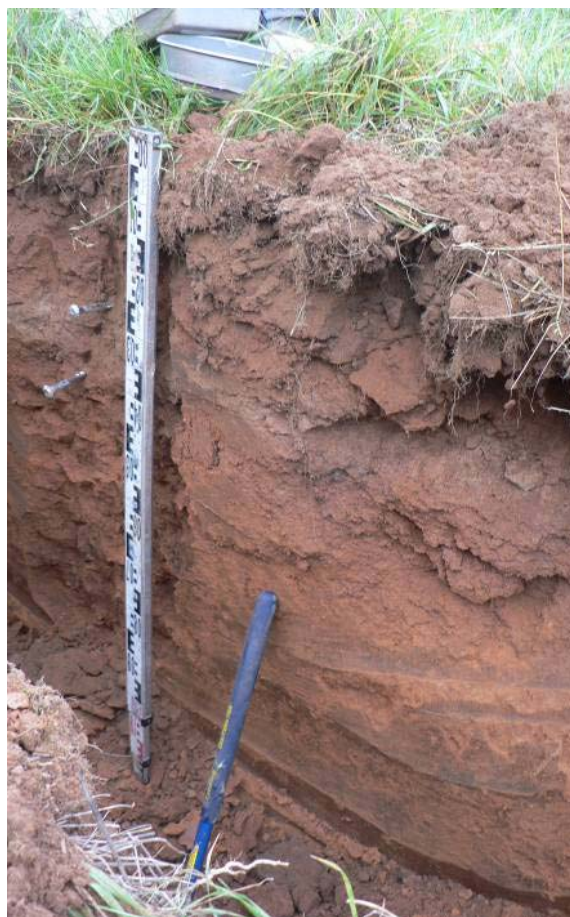
80 to 115cm

Strong brown medium clay with strong grade of prismatic structure and 5cm peds. Poor to moderate structure for root growth indicated by SOILpak score and no roots. Clods were not dispersive, partially slaked in distilled water.

Profile OD208 had a relatively small capacity to store nutrients, indicated by the moderately low cation exchange capacity, and had moderately acidic topsoil with moderate organic carbon content (**Table 4**). Available soil phosphorus and nitrate nitrogen were high for a pasture profile, but sulphate sulphur was moderately low throughout the profile. Tested micronutrients were generally present at adequate levels, but manganese was elevated, indicating that the soil may have been waterlogged. Salinity was desirably low through the profile, and cation ratios in the surface layers were acceptable. Exchangeable aluminium was elevated in the surface 60cm, and very high in the 10 to 30cm layer. The surface layers were moderately dispersive, and the soil sampled deeper than 30cm was strongly dispersive.

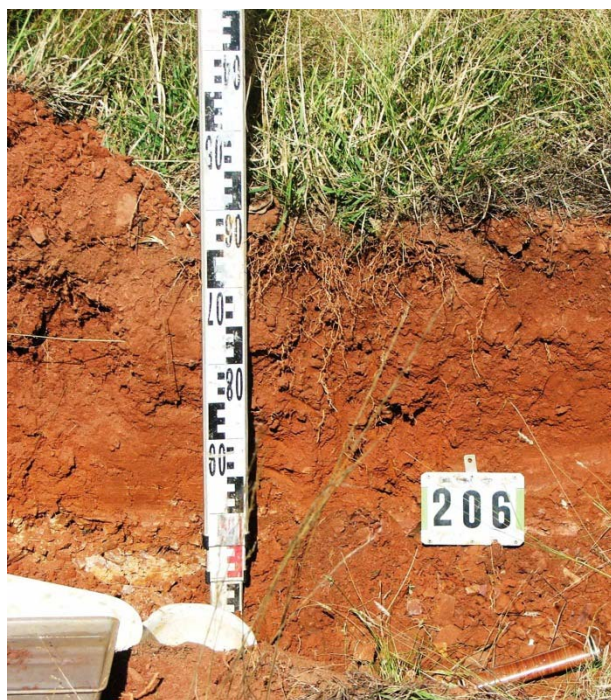
>45cm

Bedrock of hard metasediment.

Profile OD206 had a relatively small capacity to store nutrients, indicated by the moderately low cation exchange capacity, and had moderately acidic topsoil with moderate organic carbon content (**Table 7**). Available soil phosphorus, nitrate nitrogen and sulphate sulphur were lower than optimum. Tested micronutrients were generally present at adequate levels, but manganese was elevated, indicating that the soil may have been waterlogged. Salinity was desirably low through the profile, and cation ratios in the surface layers were acceptable. Exchangeable aluminium was moderately elevated in the surface 30cm. The sampled soil was moderately dispersive.

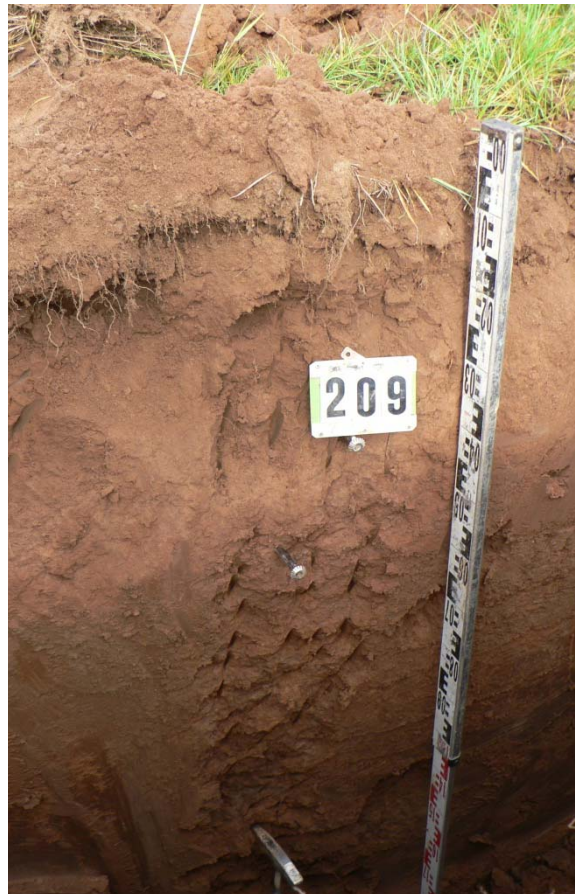
115 to 170cm

Strong brown light clay with moderate grade of angular blocky structure and 5cm peds. Poor to moderate structure for root growth indicated by SOILpak score and no roots. Clods were not dispersive, partially slaked in distilled water.

Profile OD209 had a relatively small capacity to store nutrients, indicated by the moderately low cation exchange capacity, and had moderately acidic topsoil with moderate organic carbon content (**Table 13**). Available soil phosphorus was high for a pasture profile, but nitrate nitrogen and sulphate sulphur were very low throughout the profile. Tested micronutrients were generally present at adequate levels. Salinity was desirably low through the profile, and cation ratios in the surface layers were acceptable. Exchangeable aluminium was moderately high in the surface 30cm. The surface layers were moderately dispersive, and the soil sampled deeper than 30cm was strongly dispersive. The surface sample was water stable, but deeper samples slaked considerably.

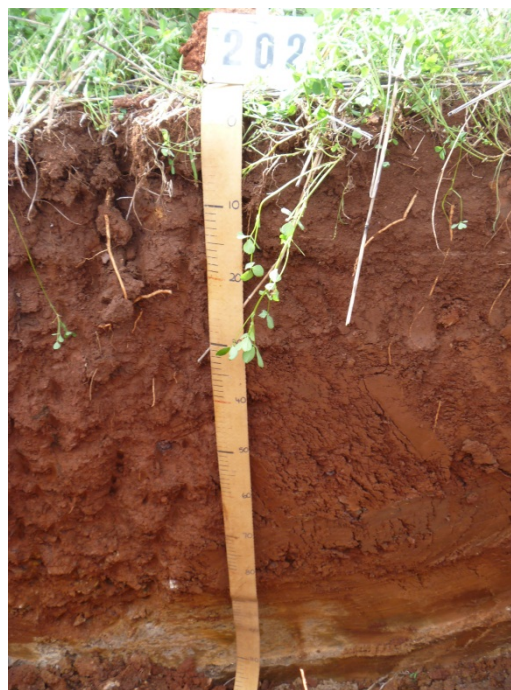
100 to 120cm

Distinctly weathered Trachyte.

Profile OD202 had a moderate capacity to store nutrients, indicated by the moderate cation exchange capacity, and had moderately acidic topsoil with moderate organic carbon content (**Table 14**). Available soil phosphorus was adequate for a pasture profile, but nitrate nitrogen

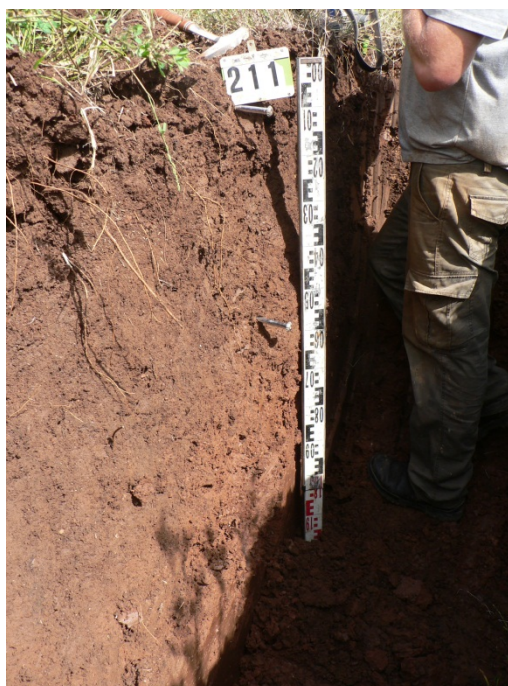
55 to 125cm

Reddish brown heavy clay with strong grade of lenticular structure and 5cm peds. Good structure for root growth indicated by SOILpak score and few roots. Clods dispersed strongly, partially slaked in distilled water.

The soil tested from the Wongarbon landscape had a moderate capacity to store nutrients, indicated by a larger cation exchange capacity than the other sites tested (**Table 17**). The soil was less acidic than the remaining profiles tested, and the organic carbon content was slightly higher. Available soil phosphorus varied from deficient in Pit OD242 to being present at luxury levels in Pit OD212. Nitrate nitrogen and sulphur were low throughout all profiles tested. Tested micronutrients were generally present at adequate levels. Salinity was desirably low through the profile except the 60 to 90cm layer of OD242, but was higher in the Wongarbon profiles than the other sites tested. Cation ratios were acceptable. Exchangeable aluminium was desirably low. The tested soil showed little tendency to disperse, apart from slight dispersion in OD207 and OD242, and the surface 10cm of OD212.

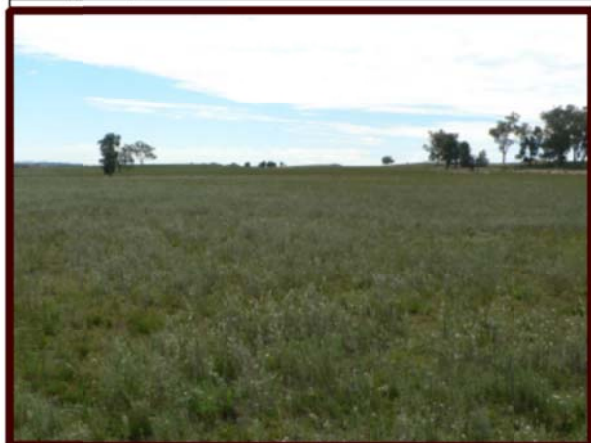
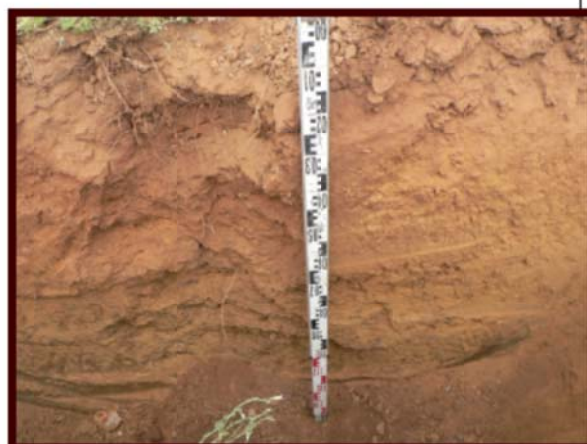
Dubbo Zirconia Project Toongi Cr262			TEST PIT OD203					
Date Excavated: 22/3/12		Logged by: PJH		Datum: WGS84				
Equipment: Hitachi EX55UR		Surface Elevation(m): 324.0		Easting: 650683				
		ECa 59 mS/m		Northing: 6407508				
DEPTH (metres)	GRAPHIC LOG	MATERIAL DESCRIPTION	SAMPLE CONSIS- TENCY	STRENGTH (kg/cm2) 7.5 15	MOISTURE	DISPERSI- ON (0 to 4)	SLAKING	EC (1:5) (dS/m)

1.5		Silty CLAY (CL) Brown yellow, moderately plastic, slow dilatancy, medium toughness, medium dry strength, structure blocky with rough surfaces, manganese mottle common Floaters coarse sandstone, Nodules manganese/ironstone Bottom of hole at 1.2	Firm		Moist	0		0.1

The material sampled from 50 to 100cm in Pit OD203 had a permeability of  $2 \times 10^{-9}$  m/sec (equivalent to 0.2mm/day/m head, **Appendix 6**) when compacted to 95% of the maximum dry density of  $1.78 \text{ t/m}^3$  at the optimum moulding moisture of 13.3% (gravimetric). This is adequate performance for water storages.

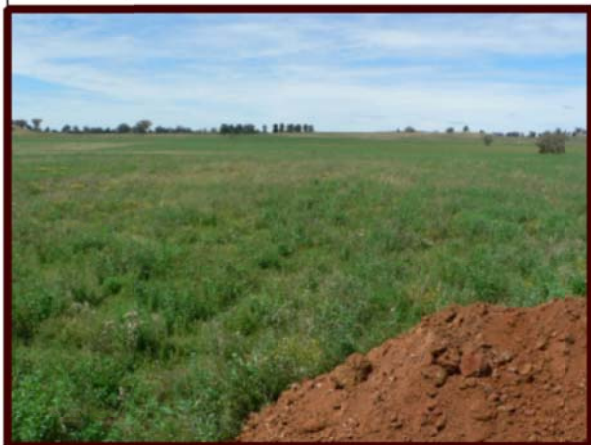
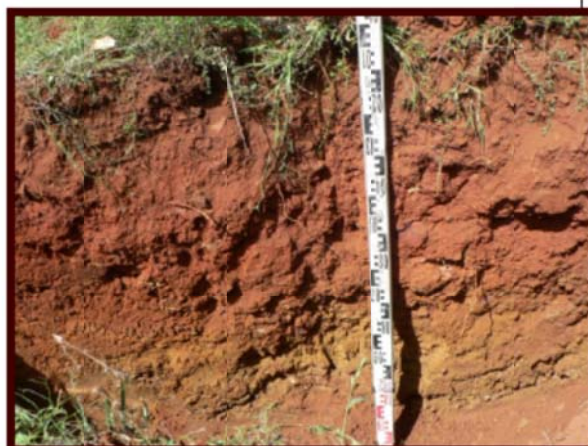
Dubbo Zirconia Project Toongi Cr262			TEST PIT OD204						
Date Excavated: 22/3/12		Logged by: PJH		Datum: WGS84					
Equipment: Hitachi EX55UR		Surface Elevation(m): 297.0		Easting: 649972					
		ECa 46 mS/m		Northing: 6408757					
DEPTH (metres)	GRAPHIC LOG	MATERIAL DESCRIPTION	SAMPLE	CONSIS- TENCY	STRENGTH (kg/cm2)	MOISTURE	DISPERSI- ON (0 to 4)	SLAKING	EC (1:5) (dS/m)
		Gravelly CLAY (CL) Orange red, slightly plastic, no dilatancy, low toughness, medium dry strength, structure blocky with rough surfaces, little silt; 30% subrounded sand		Firm		Moist	0	Partial

2.0		EXTREMELY WEATHERED CONGLOMERATE Brown yellow, matrix extremely weathered , extremely low strength Hill appears to be weathered conglomerate Bottom of hole at 1.4

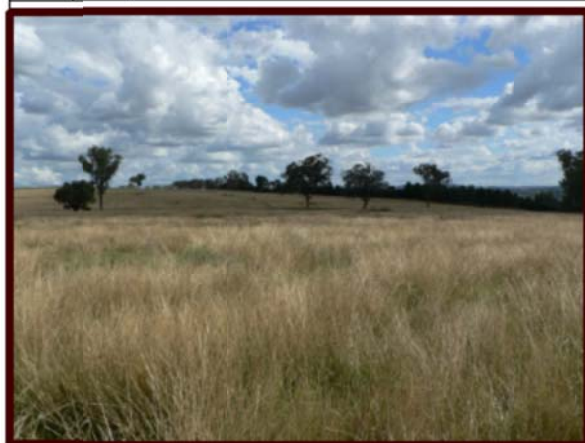
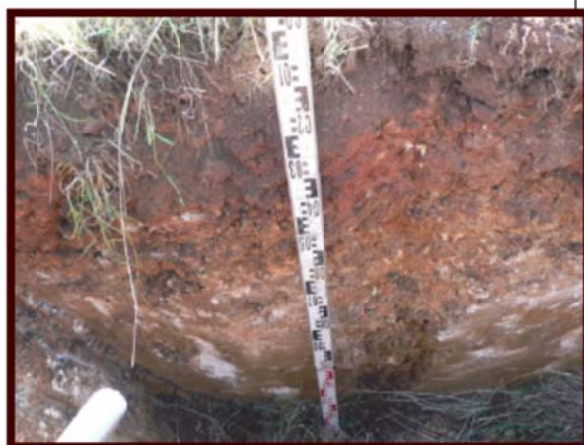
Dubbo Zirconia Project Toongi Cr262		TEST PIT OD207						
Date Excavated: 22/3/12		Logged by: PJH		Datum: WGS84				
Equipment: Hitachi EX55UR		Surface Elevation(m): 377.0		Easting: 651668				
		ECa 122 mS/m		Northing: 6405509				
DEPTH (metres)	GRAPHIC LOG	MATERIAL DESCRIPTION	SAMPLE CONSIS- TENCY	STRENGTH (kg/cm <sup>2</sup> )	MOISTURE	DISPERSI- ON (0 to 4)	SLAKING	EC (1:5) (dS/m)
		CLAY (CH) Red brown, strongly plastic, no dilatancy, high toughness, high dry strength, structure blocky with polished surfaces,	Hard		Moist	0	Partial

1.0		CLAY (CH) Brown yellow, strongly plastic, no dilatancy, high toughness, high dry strength, structure blocky with polished surfaces, some slickensides	Stiff		Moist	0	Partial	0.6

1.5		Parent material is basalt Bottom of hole at 1.5						
2.0								
2.5

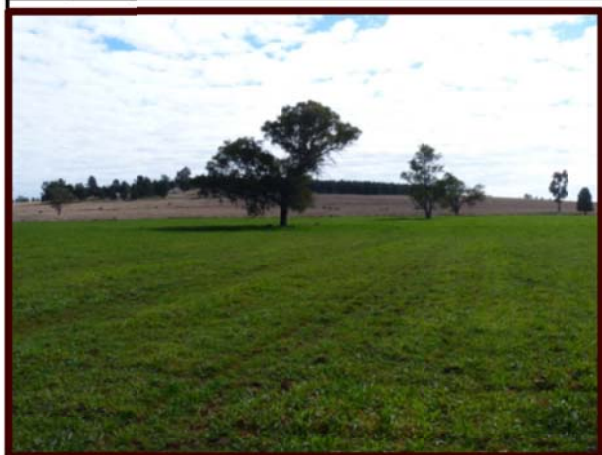
Dubbo Zirconia Project Toongi Cr262			TEST PIT OD238						
Date Excavated: 25/7/12			Logged by: PJH		Datum: WGS84				
Equipment: Hitachi EX55UR			Surface Elevation(m): 313.3		Easting: 654435				
			ECa 67 mS/m		Northing: 6409623				
DEPTH (metres)	GRAPHIC LOG	MATERIAL DESCRIPTION	SAMPLE	CONSIS- TENCY	STRENGTH (kg/cm2)	MOISTURE	DISPERSI- ON (0 to 4)	SLAKING	EC (1:5) (dS/m)
		Clayey SAND (SC) Dark grey, fine to medium, subangular, poorly sorted, fines clayey, loosely packed, with clayey silt, roots common.				Moist	2	Partial	0

0.5		CLAY (CH) Yellow grey, strongly plastic, no dilatancy, high toughness, high dry strength, trace medium sand, structure blocky with rough surfaces, macropores common.		Firm		Moist	4	Partial	0
		Sandy CLAY (CL) Orange yellow, moderately plastic, no dilatancy, high toughness, medium dry strength, trace medium sand, structure blocky with rough surfaces, cemented layer 90 to 95 cm. cobbles extremely weathered sandstone common.		Firm		Moist	3	Complete	0.2

1.5		Bottom of hole at 1.4							
2.0									
2.5

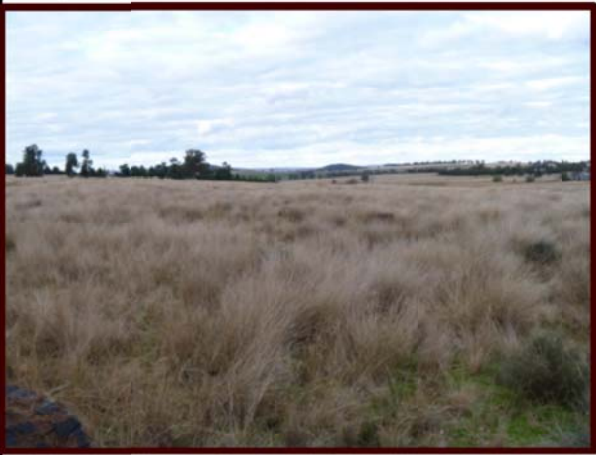
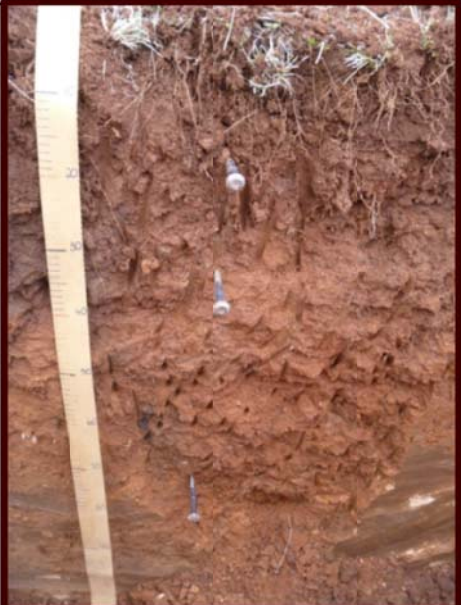
Dubbo Zirconia Project Toongi Cr262		TEST PIT OD239							
Date Excavated: 25/7/12		Logged by: PJH		Datum: WGS84		Easting: 653075		Northing: 6409634	
Equipment: Hitachi EX55UR		Surface Elevation(m): 330.5		ECa 111 mS/m					
DEPTH (metres)	GRAPHIC LOG	MATERIAL DESCRIPTION	SAMPLE	CONSIS- TENCY	STRENGTH (kg/cm2)	MOISTURE	DISPERSI- ON (0 to 4)	SLAKING	EC (1:5) (dS/m)

1.5		CLAY (CH) Grey brown, strongly plastic, no dilatancy, high toughness, high dry strength, trace fine sand, structure blocky with polished surfaces, carbonate nodules common.,	Stiff			Dry	0	Complete	1.3

2.0		Bottom of hole at 1.2							
2.5
