Cudgen Lakes Sand Extraction Project

Acid Sulfate Soils, Soil Contamination & Agricultural Suitability Assessment

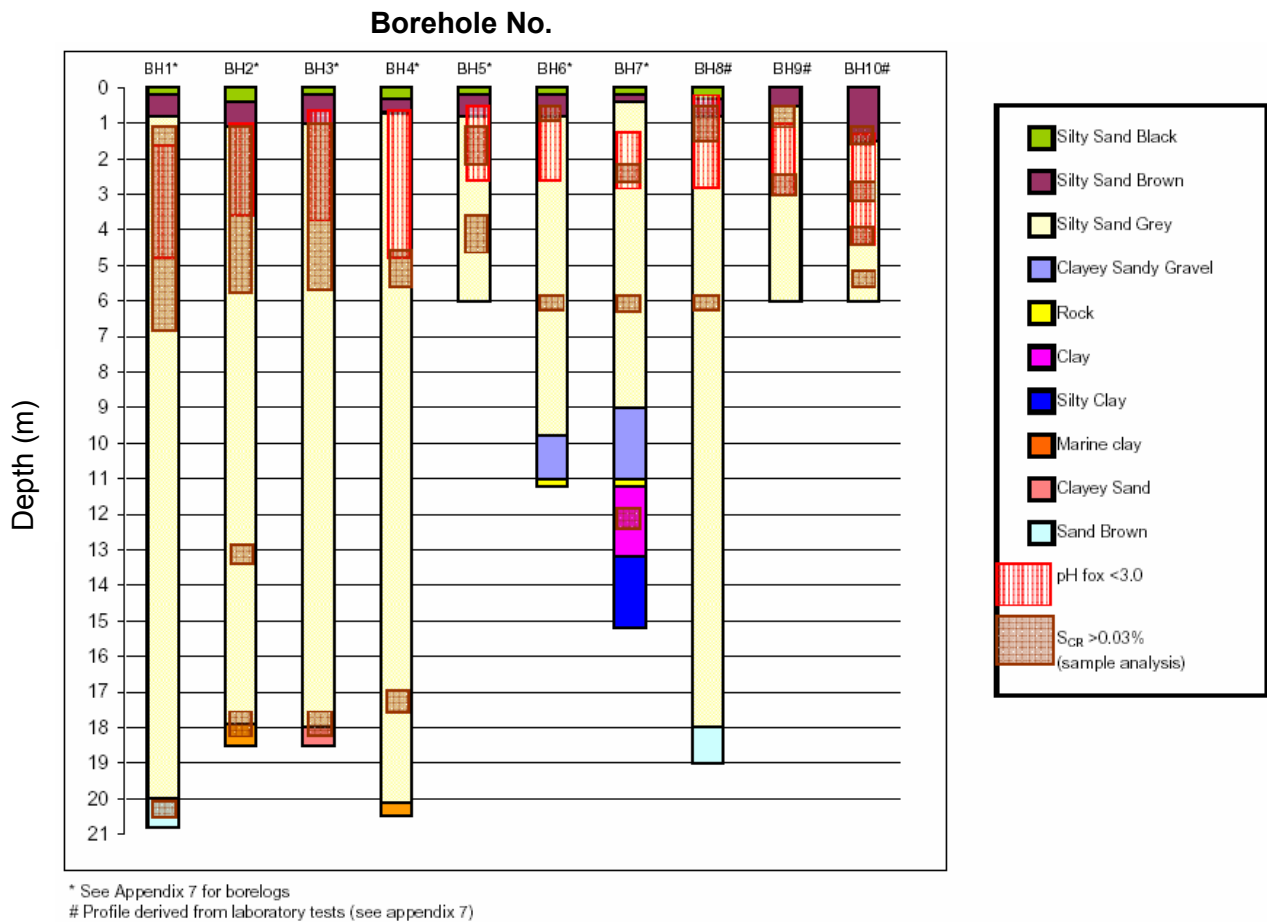
Figure 9
Soil Profiles within Boreholes

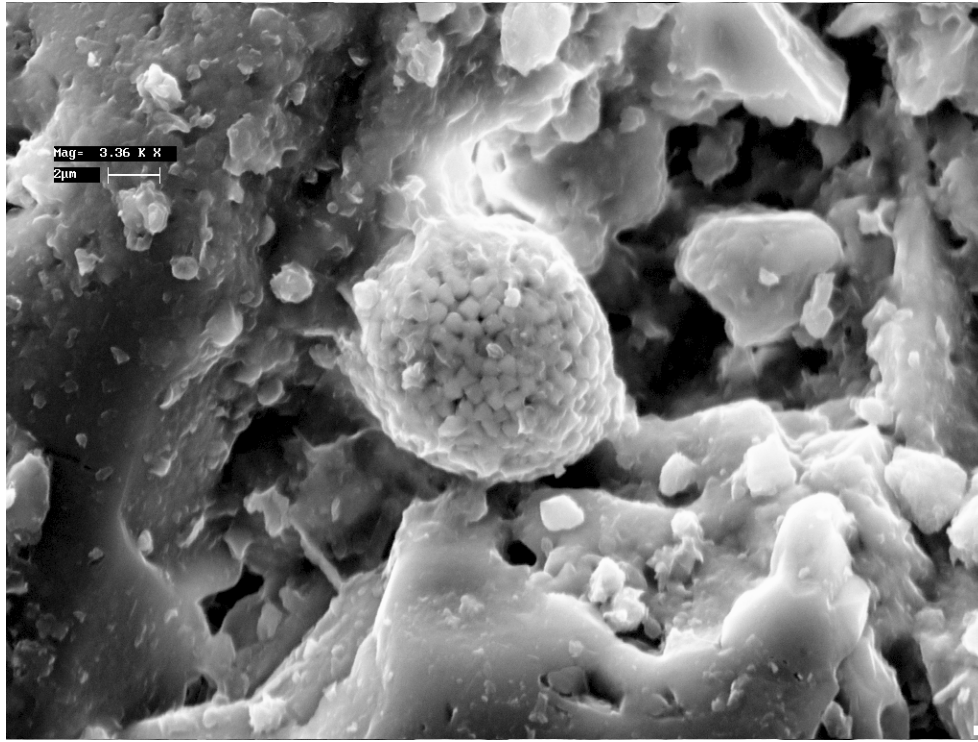
Figure 11
Scanning Electron Microscope Image - Pyrite Framboid
(Source: EAL 2006)

Pyrite framboids were noted in the samples from 3.0m, 5.0m, and 10.0m depth (see **Figures 11** and **12**). No framboids were noted in the sample from 2.5m depth. These results support the laboratory analysis undertaken on these samples which recorded elevated levels of oxidisable sulfur in the samples from 3.0m, 5.0m and 10.0m depth. Very low levels of oxidisable sulfur (0.01%) were measured in the sample from 2.5m depth.

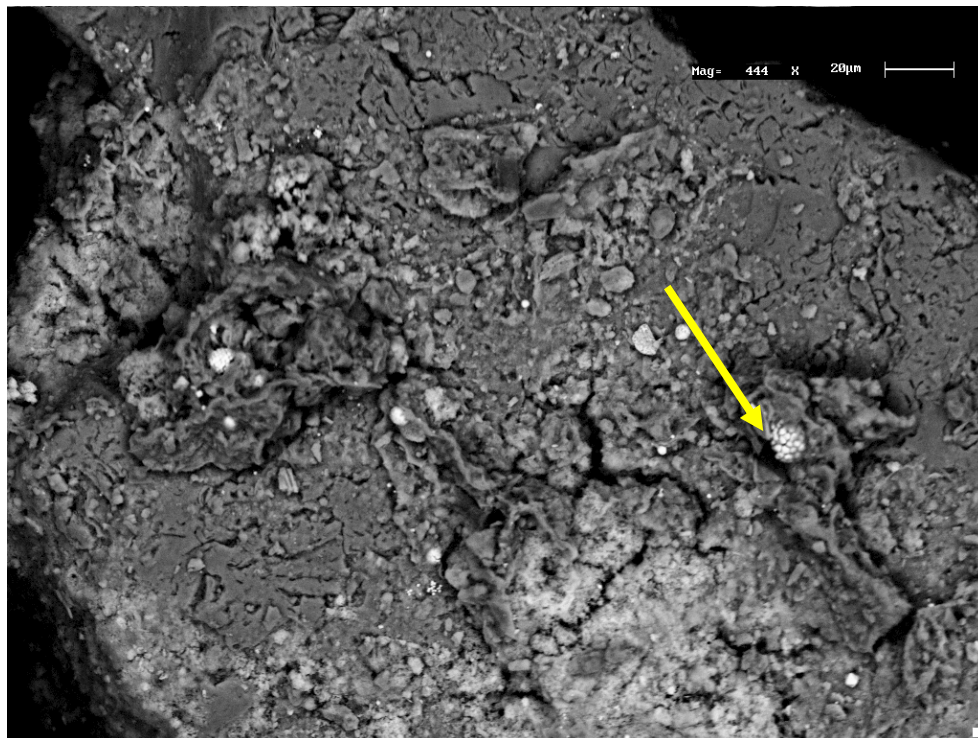
Figure 12
Scanning Electron Microscope Image - Pyrite Framboids on Sand Grain
(Source: EAL 2006)

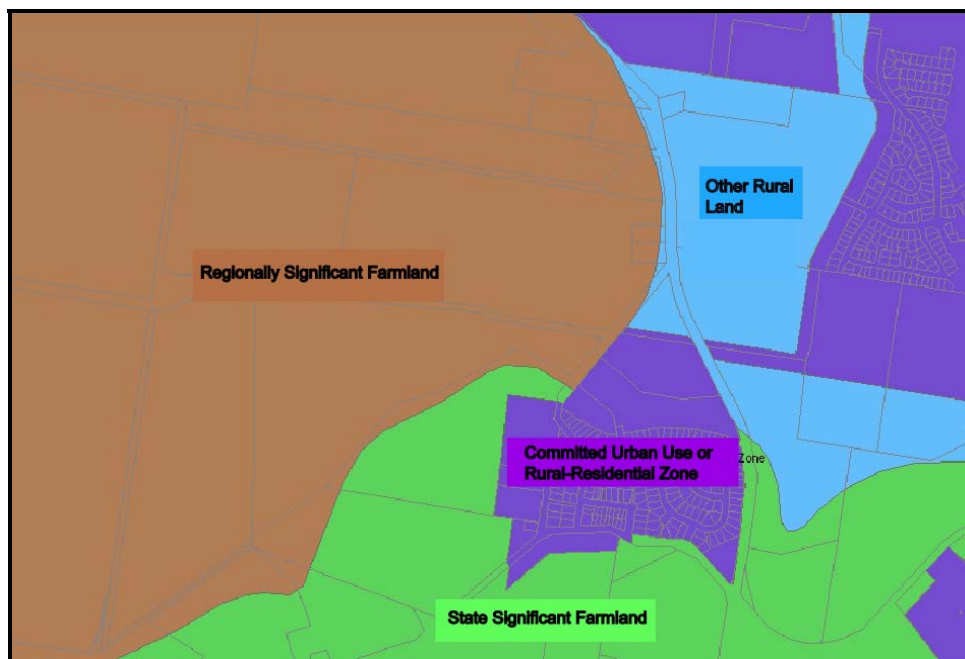
Figure 14
Farmland Protection Mapping (Tweed Shire Council GIS)

The Project Site is located within an area mapped as Regionally Significant Farmland (see **Figure 14**).

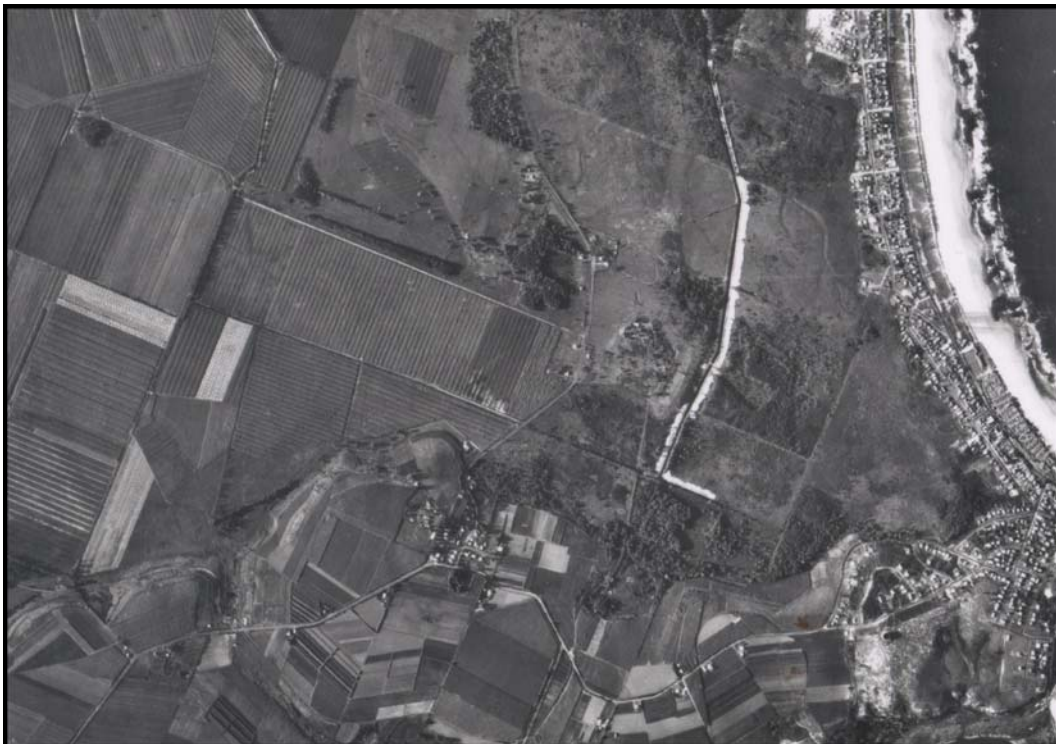
Figure 2
Aerial Photo 1970

The 1970 aerial photo (see **Appendix 2**) appears to show intensive drainage typical of sugar cane cultivation, therefore, the cane may have been on the site a few years earlier than 1973. No cane drainage is noted in the 1962 aerial photo (see **Appendix 2**). Interestingly, the 1974 topographic map (see **Appendix 2**) does not indicate sugar cane cultivation on the site although the map would have been based on investigation and interpretation work undertaken several years earlier.

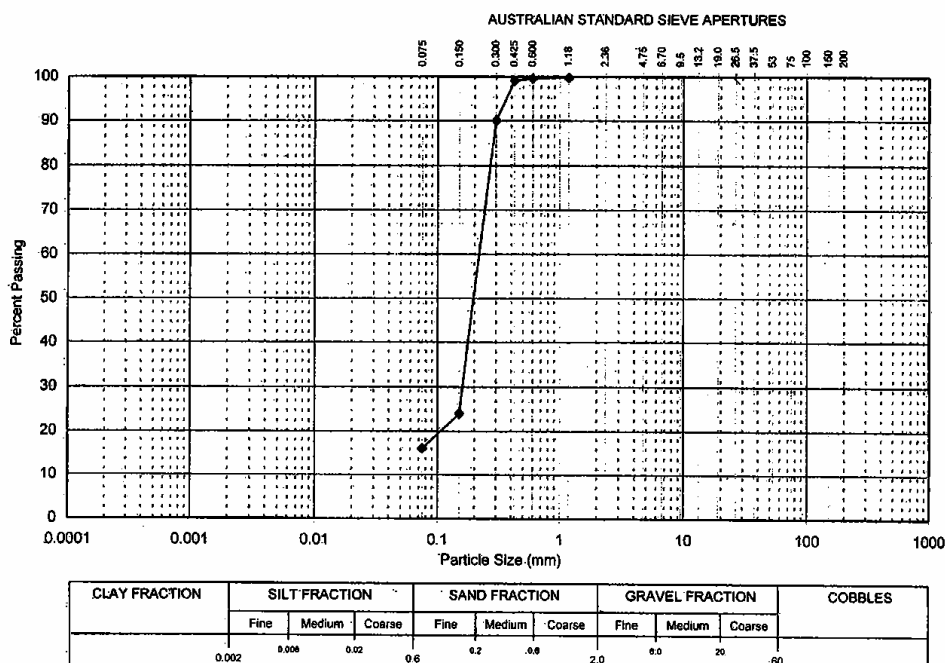
Description: SAND - slightly silty, grey, fine to medium grained.
Test Method(s): AS 1289.3.6.1-1995.
Sampling Method(s): By Client
Method of Dispersion:
Remarks:

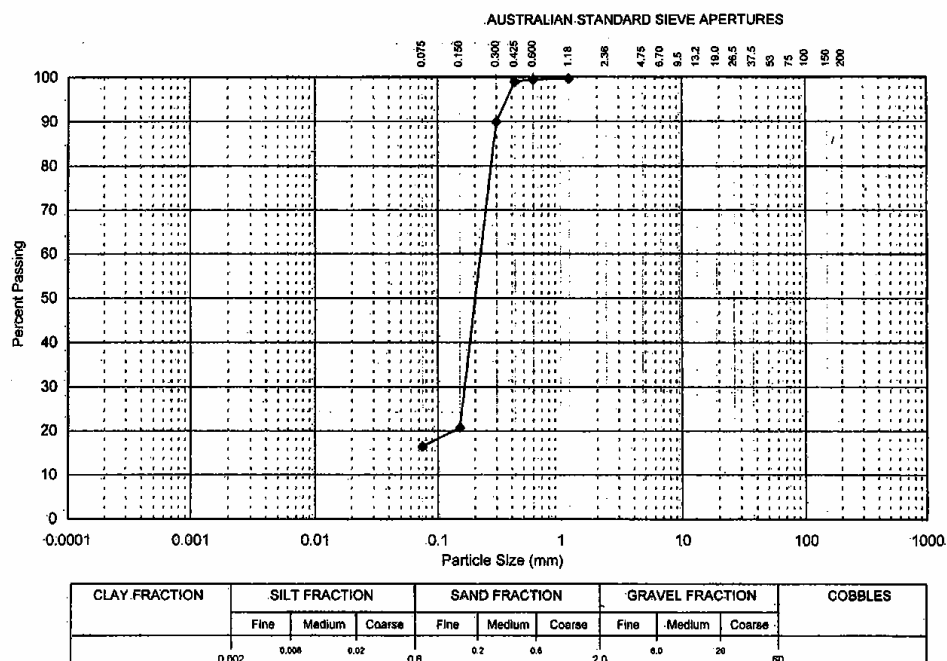
Description: SAND - Slightly silty, light brown, fine to medium grained
Test Method(s): AS 1289.3.6.1-1995.
Sampling Method(s): By Client
Method of Dispersion:
Remarks:

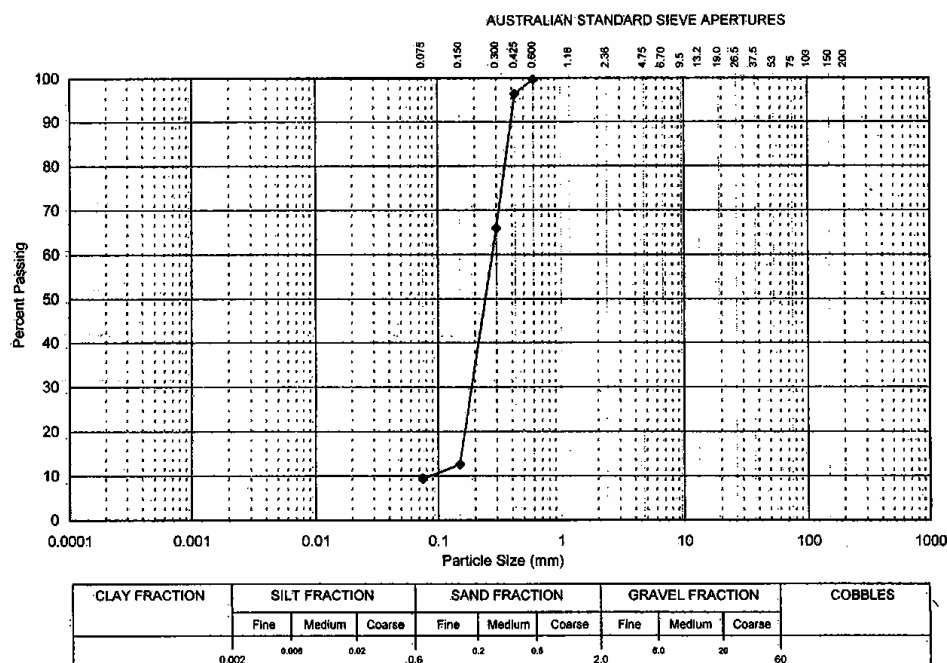
Description: SAND - Light Brown, medium grained with some silt.
Test Method(s): AS 1289.3.6.1-1995.
Sampling Method(s): By Client
Method of Dispersion:
Remarks:

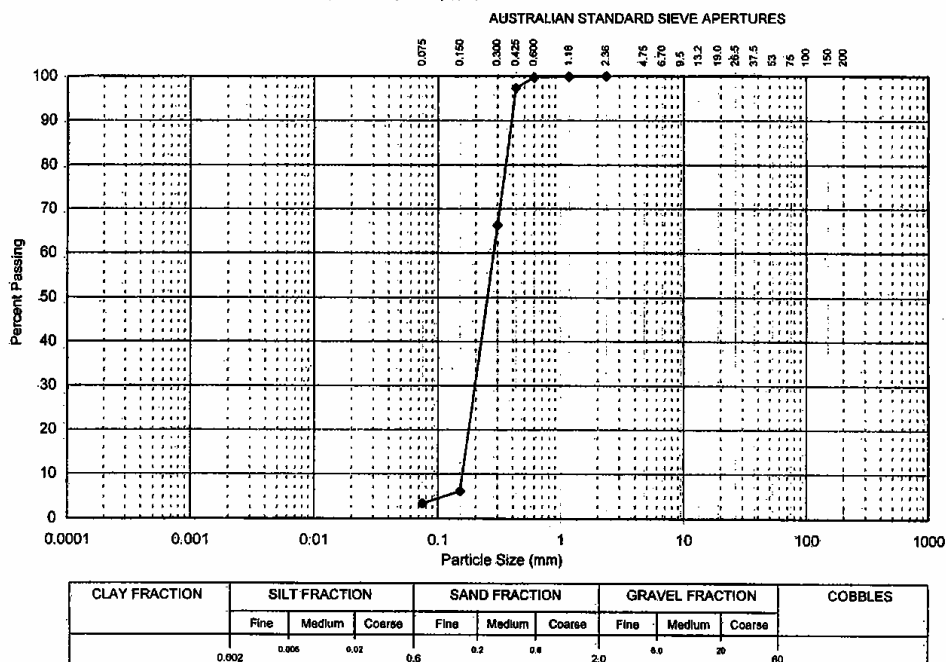
Description: SAND - Grey, medium grained with a trace of silt.

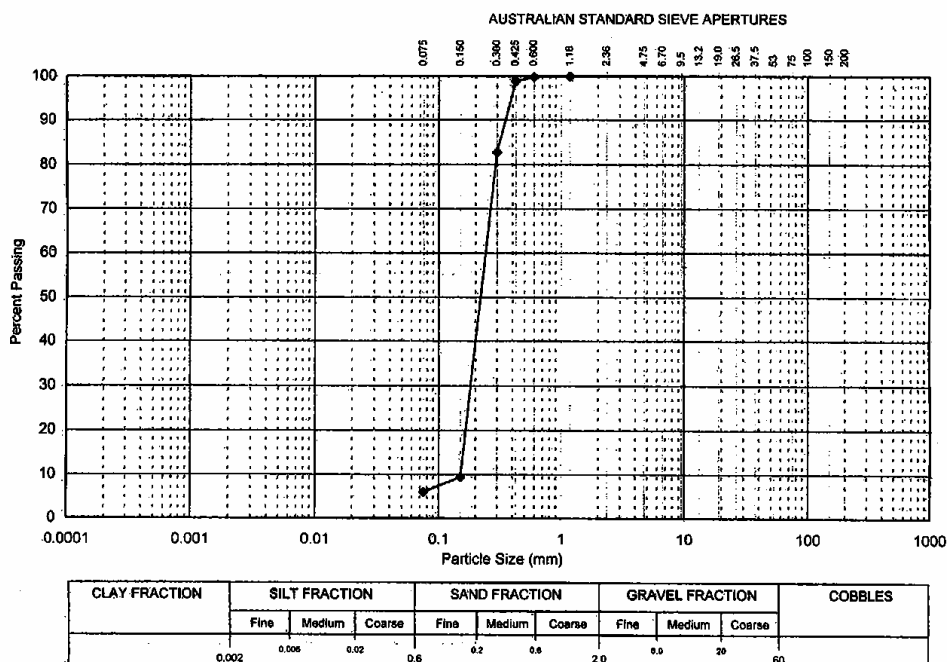
Description: SAND - Grey, medium grained with some silt.
